**Flood Control Project Maintenance  
Levee Inspections**  
**LMA District Cover Sheet**  
**Spring 2019 Levee Inspection Results**

**Sutter Maintenance Yard East-West Interceptor**

**Spring 2019 Levee Inspection Results**

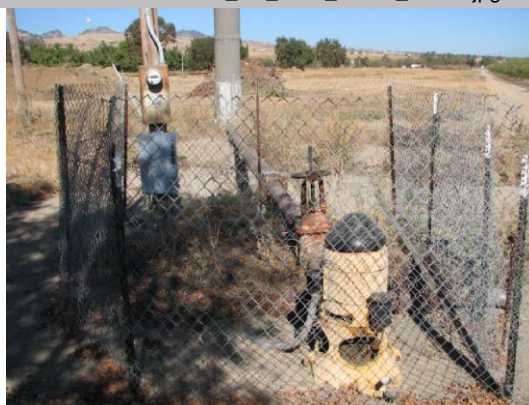
Photo 1 of 3 : UCIP\_SP\_2019\_53691\_11344.jpg

Comment Code					
Inspector Comment					
FS_ID:53691 DS_ID:19417 EP_NO: N/A Repair Type: Non-Urgent Crossing Status: Found UCIP Comments: 02/12/2012 Groundwater system does not cross high ground section (known as project levee). Record will remain part of UCIP inventory however, pipe does not go through designated project levee. (O. Magana - DWR UCIP)4/10/2017 Crossing appears to have been abandoned. (DWR Sutter Yard- A Freitag)4/19/2016 Meter has been removed from the power box and the power lines have been disconnected from the pole and pump. Appears this crossing may have been abandoned.5/12/2015 Crossing appears in good condition. No noticeable issues to report.11/17/2014 Same as last inspection.5/12/2014 Same as last inspection.11/4/2013 Same as last inspection.5/15/2013 Same as last inspection. FIELD_STRUCT_DESC: *NOT THROUGH LEVEE* 12-inch steel irrigation pipe crosses over canal above crown elevation. Chain link enclosure on the landside (LS) with pump, power line, and shutoff valve. 24-inch concrete standpipe on unprotected side of canal. [Additional Reference(s): DWR Levee Log, Revised 1990] FS Date: 2/12/2019 10:18:00 AM

Pump, meter, power pole, slide gate, and chainlink fence on LS with 24-inch concrete standpipe on unprotected side of canal.

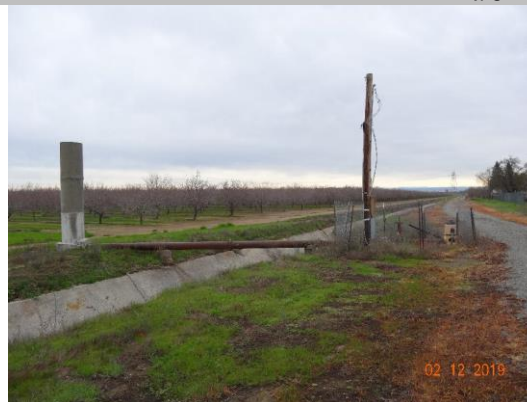
Photo 3 of 3 : UCIP\_SP\_2019\_53691\_78912.jpg

Comment Code						
Inspector Comment						
FS_ID:53691 DS_ID:19417 EP_NO: N/A Repair Type: Non-Urgent Crossing Status: Found UCIP Comments: 02/12/2012 Groundwater system does not cross high ground section (known as project levee). Record will remain part of UCIP inventory however, pipe does not go through designated project levee. (O. Magana - DWR UCIP)4/10/2017 Crossing appears to have been abandoned. (DWR Sutter Yard- A Freitag)4/19/2016 Meter has been removed from the power box and the power lines have been disconnected from the pole and pump. Appears this crossing may have been abandoned.5/12/2015 Crossing appears in good condition. No noticeable issues to report.11/17/2014 Same as last inspection.5/12/2014 Same as last inspection.11/4/2013 Same as last inspection.5/15/2013 Same as last inspection. FIELD_STRUCT_DESC: *NOT THROUGH LEVEE* 12-inch steel irrigation pipe crosses over canal above crown elevation. Chain link enclosure on the landside (LS) with pump, power line, and shutoff valve. 24-inch concrete standpipe on unprotected side of canal. [Additional Reference(s): DWR Levee Log, Revised 1990] FS Date: 2/12/2019 10:18:00 AM

WS view: groundwater pipe system located on WS and across opposite bank.

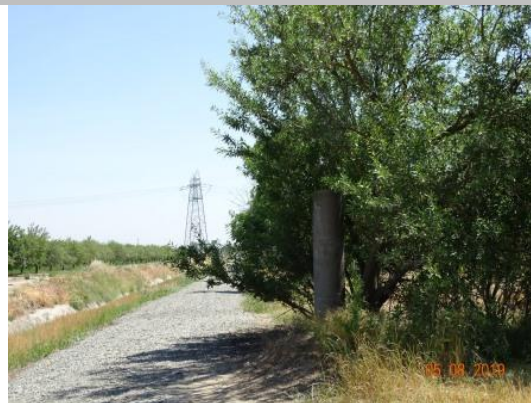
Photo 1 of 1 : SP\_2019\_ST0020\_213\_15\_20190510\_00031.jpg

View of the trees on the landside slope. Spring 2019.

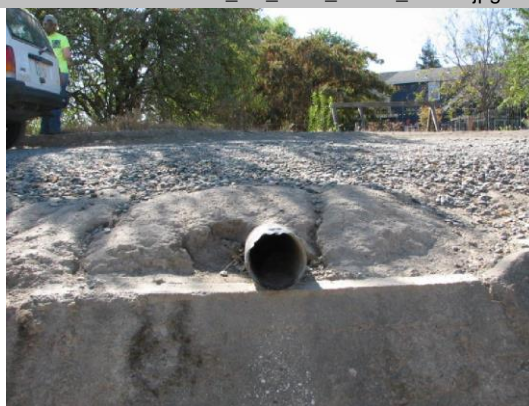
Photo 1 of 3 : UCIP\_SP\_2019\_53693\_64242.jpg

Comment Code					
Inspector Comment					
FS_ID:53693 DS_ID:20115 EP_NO: N/A Repair Type: Non-Urgent Crossing Status: Found UCIP Comments: 02/12/2019 (O. Magana - DWR UCIP)4/10/2017 Overgrown vegetation was blocking access to this pipe. It was not inspected. (DWR Sutter Yard- AFreitag)10/11/2016 Crossing appears to be in good condition.(DWR Sutter Yard - afreitag)4/19/2016 Crossing appears to be in good condition.5/12/2015 Crossing appears in good condition. No noticeable issues to report.11/17/2014 Same as last inspection.5/12/2014 New flapgate installed on WS pipe end.11/4/2013 Same as last inspection.5/15/2013 Same as last inspection.10/16/2012 Pipe not permitted and has no flap gate. FIELD_STRUCT_DESC: 8-inch corrugated metal drainage pipe through the levee, 1.5 feet below the crown. Outlet visible on the waterside (WS). Unable to locate the inlet on the landside (LS). No permit has been identified since crossing was field discovered in 2012. Pipe drains adjacent property. FS Date: 2/12/2019 10:19:00 AM

Pipe at outlet on WS crown.

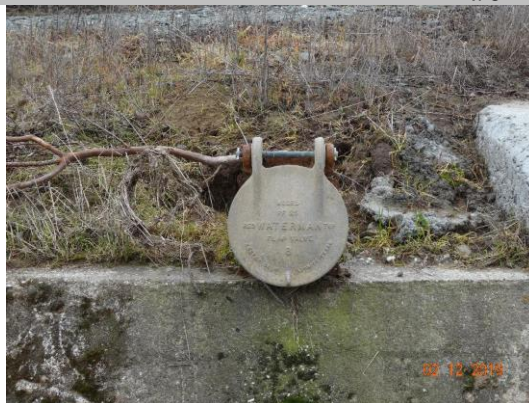
Photo 3 of 3 : UCIP\_SP\_2019\_53693\_78922.jpg

Comment Code					
Inspector Comment					
FS_ID:53693 DS_ID:20115 EP_NO: N/A Repair Type: Non-Urgent Crossing Status: Found UCIP Comments: 02/12/2019 (O. Magana - DWR UCIP)4/10/2017 Overgrown vegetation was blocking access to this pipe. It was not inspected. (DWR Sutter Yard- A Freitag)10/11/2016 Crossing appears to be in good condition.(DWR Sutter Yard - a Freitag)4/19/2016 Crossing appears to be in good condition.5/12/2015 Crossing appears in good condition. No noticeable issues to report.11/17/2014 Same as last inspection.5/12/2014 New flapgate installed on WS pipe end.11/4/2013 Same as last inspection.5/15/2013 Same as last inspection.10/16/2012 Pipe not permitted and has no flap gate. FIELD_STRUCT_DESC: 8-inch corrugated metal drainage pipe through the levee, 1.5 feet below the crown. Outlet visible on the waterside (WS). Unable to locate the inlet on the landside (LS). No permit has been identified since crossing was field discovered in 2012. Pipe drains adjacent property. FS Date: 2/12/2019 10:19:00 AM

WS view: flap gate visible on WS.

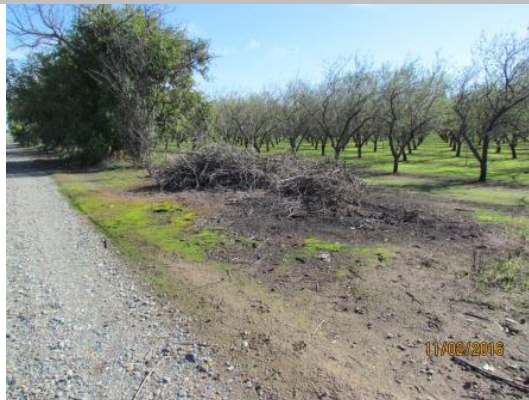
Photo 1 of 1 : SP\_2019\_ST0020\_213\_19\_20190327\_00012.jpg

LM Start	1.11	Rating **	M	Issue No.	19
LM End	1.11	Issue Type +	En	Location *	LS
Category	Earthen Levee			GPS Latitude/Longitude	
				Start	End
Item	Encroachments			39.171283 °	39.171283 °
				-121.739315 °	-121.739315 °
DWR ID	DWR_ST0020_01_f_2016_19				
Comment Code					
PR : Prunings					
Inspector Comment					
Remove prunings from the landside toe.

View of the prunings along the landside toe.

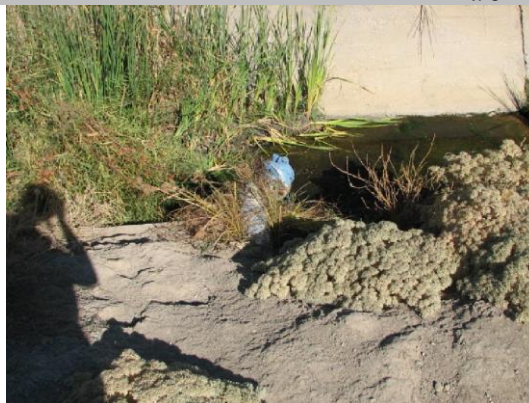
Photo 1 of 3 : UCIP\_SP\_2019\_53832\_11347.jpg

Comment Code						
Inspector Comment						
FS_ID:53832 DS_ID:19433 EP_NO: 15946 Repair Type: Urgent Crossing Status: Found UCIP Comments: 02/12/2019 System description was updated based on permit records and field observations. Crossing has been updated as a drainage pipe and not an irrigation crossing. Damage to the WS bank should be addressed. (O. Magana - DWR UCIP)4/10/2017 Crossing appears to be in good condition. (DWR Sutter Yard-AFreitag)10/11/2016 Crossing appears to be in good condition.(DWR Sutter Yard - afreitag)4/19/2016 Crossing appears to be in good condition.5/12/2015 Crossing appears in good condition. No noticeable issues to report.5/15/2013 Same as last inspection.11/4/2013 Same as last inspection.5/12/2014 Same as last inspection.11/17/2014 Same as last inspection. FIELD_STRUCT_DESC: 6-inch polyvinyl chloride (PVC) drainage pipe through the levee, 2 feet below the crown. Flap gate located on the waterside (WS). Pipe runs from building on the landside (LS) toe to canal. Line is an intermittent line only that conveys water from over-pressure relief and bypass valves in a municipal water pump station on adjacent Sutter Community Services District property. Permit was issued for a 6-inch polyvinyl chloride (PVC) water line to be allowed outside the project levee section and outside 10 feet of the levee toes and steel within the project levee section. (6-inch and 12-inch pipes, different locations, authorized under Permit No. 15946, 1992 - Sutter Community Services District; design sketch available in permit, page 21-23). FS Date: 2/12/2019 10:19:00 AM

Pipe at LS shoulder next to canal.

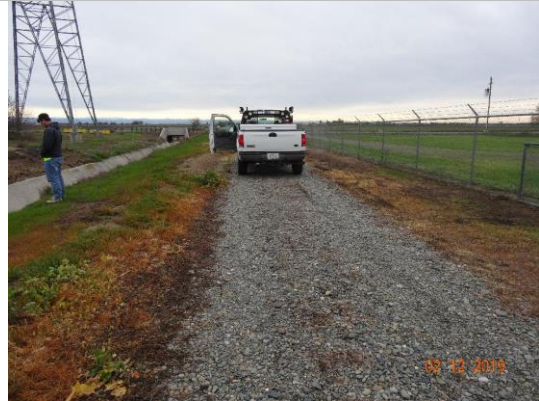
Photo 3 of 3 : UCIP\_SP\_2019\_53832\_78926.jpg

Comment Code						
Inspector Comment						
FS_ID:53832 DS_ID:19433 EP_NO: 15946 Repair Type: Urgent Crossing Status: Found UCIP Comments: 02/12/2019 System description was updated based on permit records and field observations. Crossing has been updated as a drainage pipe and not an irrigation crossing. Damage to the WS bank should be addressed. (O. Magana - DWR UCIP)4/10/2017 Crossing appears to be in good condition. (DWR Sutter Yard-AFreitag)10/11/2016 Crossing appears to be in good condition.(DWR Sutter Yard - afreitag)4/19/2016 Crossing appears to be in good condition.5/12/2015 Crossing appears in good condition. No noticeable issues to report.5/15/2013 Same as last inspection.11/4/2013 Same as last inspection.5/12/2014 Same as last inspection.11/17/2014 Same as last inspection. FIELD_STRUCT_DESC: 6-inch polyvinyl chloride (PVC) drainage pipe through the levee, 2 feet below the crown. Flap gate located on the waterside (WS). Pipe runs from building on the landside (LS) toe to canal. Line is an intermittent line only that conveys water from over-pressure relief and bypass valves in a municipal water pump station on adjacent Sutter Community Services District property. Permit was issued for a 6-inch polyvinyl chloride (PVC) water line to be allowed outside the project levee section and outside 10 feet of the levee toes and steel within the project levee section. (6-inch and 12-inch pipes, different locations, authorized under Permit No. 15946, 1992 - Sutter Community Services District; design sketch available in permit, page 21-23). FS Date: 2/12/2019 10:19:00 AM

Overview of levee crown (high ground) looking east where pipe crosses.

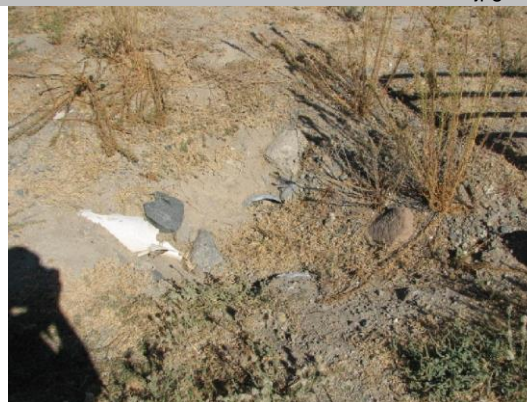
Photo 3 of 3 : UCIP\_SP\_2019\_53831\_11348.jpg

Comment Code						
Inspector Comment						
FS_ID:53831 DS_ID:19432 EP_NO: 15946 Repair Type: Urgent Crossing Status: Found UCIP Comments: 02/12/2019 (O. Magana - DWR UCIP)4/10/2017 Crossing appears to be in good condition. (DWR Sutter Yard-AFreitag)10/11/2016 Crossing appears to be in good condition. (DWR Sutter Yard - afreitag)4/19/2016 LS inlet has been cleaned out. Crossing appears in good condition.5/12/2015 LS inlet is still completely blocked with soil.11/17/2014 Same as last inspection.5/12/2014 Same as last inspection.5/15/2013 Same as last inspection.11/4/2013 Same as last inspection.10/16/2012 Inlet is completely blocked with soil. FIELD_STRUCT_DESC: 12-inch corrugated metal drainage pipe through the levee, 2 feet below the crown. Pipe is encased in concrete. Flap gate is located on the waterside (WS). Landside (LS) inlet filled with soil. (12-inch and 6-inch pipes, different locations, authorized under Permit No. 15946, 1992 - Sutter Community Services District; design sketch available in permit, page 21-23). FS Date: 2/12/2019 10:19:00 AM

Soil filled inlet on LS of crown.

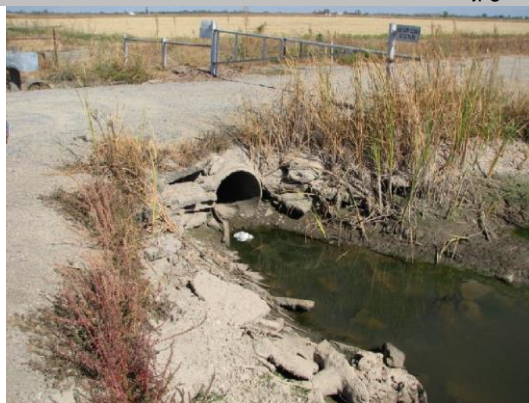
Photo 2 of 3 : UCIP\_SP\_2019\_53696\_11352.jpg

Comment Code						
Inspector Comment						
FS_ID:53696 DS_ID:19422 EP_NO: N/A Repair Type: Non-Urgent Crossing Status: Found UCIP Comments: 02/12/2019 (O. Magana - DWR UCIP)4/10/2017 Crossing appears to be in good condition. Pipe material is concrete. (DWR Sutter Yard- AFreitag)10/11/2016 Crossing appears to be in good condition. (DWR Sutter Yard - afreitag)4/19/2016 Crossing appears to be in good condition.5/12/2015 Crossing appears in good condition. No noticeable issues to report.11/17/2014 Same as last inspection.5/12/2014 Same as last inspection.11/4/2013 Same as last inspection.5/15/2013 Same as last inspection. FIELD_STRUCT_DESC: 30-inch reinforced concrete irrigation pipe through the levee, 2 feet below the crown. 30-inch steel pipe also passes over canal in same alignment. [Additional Reference(s): DWR Levee Log, Revised 1990]. FS Date: 2/12/2019 10:20:00 AM

LS of pipe at inlet.

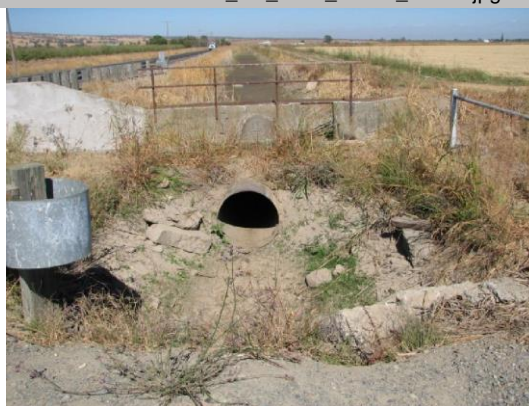
Photo 3 of 3 : UCIP\_SP\_2019\_53696\_11351.jpg

Comment Code						
Inspector Comment						
FS_ID:53696 DS_ID:19422 EP_NO: N/A Repair Type: Non-Urgent Crossing Status: Found UCIP Comments: 02/12/2019 (O. Magana - DWR UCIP)4/10/2017 Crossing appears to be in good condition. Pipe material is concrete. (DWR Sutter Yard- A Freitag)10/11/2016 Crossing appears to be in good condition. (DWR Sutter Yard - a Freitag)4/19/2016 Crossing appears to be in good condition.5/12/2015 Crossing appears in good condition. No noticeable issues to report.11/17/2014 Same as last inspection.5/12/2014 Same as last inspection.11/4/2013 Same as last inspection.5/15/2013 Same as last inspection. FIELD_STRUCT_DESC: 30-inch reinforced concrete irrigation pipe through the levee, 2 feet below the crown. 30-inch steel pipe also passes over canal in same alignment. [Additional Reference(s): DWR Levee Log, Revised 1990]. FS Date: 2/12/2019 10:20:00 AM

30-inch steel pipe crossing over canal.

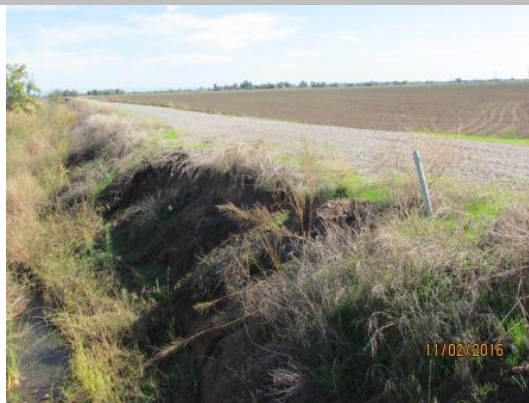
Photo 1 of 1 : SP\_2019\_ST0020\_213\_24\_20190327\_00015.jpg

LM Start	1.36	Rating **	M	Issue No.	24
LM End	1.36	Issue Type +	Ma	Location *	WS
Category	Earthen Levee			GPS Latitude/Longitude	
				Start	End
Item	Erosion / Bank Caving			39.171220 °	39.171220 °
				-121.734730 °	-121.734730 °
DWR ID	DWR_ST0020_01_f_2016_24				
Comment Code					
E1 : Note and monitor erosion site.					
Inspector Comment

View of the erosion along the bank.

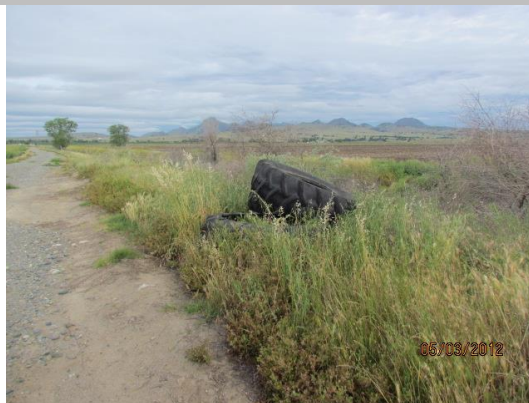
Photo 1 of 1 : SP\_2019\_ST0020\_214\_12\_20190327\_00007.jpg

View of the tires along the WS toe.

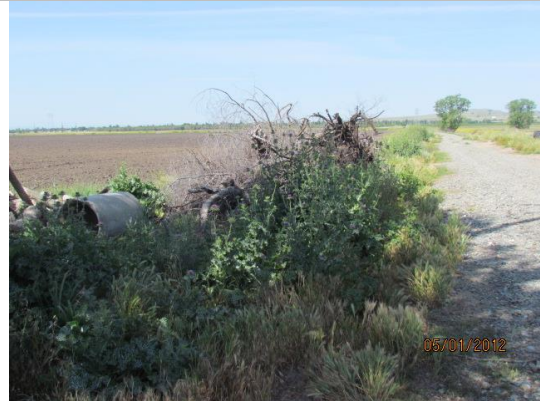
Photo 1 of 1 : SP\_2019\_ST0020\_214\_9\_20190327\_00005.jpg

View of the debris along the landside toe.

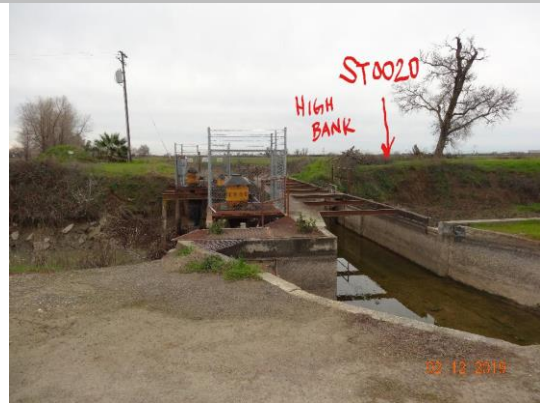
Photo 1 of 3 : UCIP\_SP\_2019\_53743\_78937.jpg

Comment Code						
Inspector Comment						
FS_ID:53743 DS_ID:19424 EP_NO: N/A Repair Type: Non-Urgent Crossing Status: Found UCIP Comments: 02/12/2019 Pump and power pole have been removed. 15-inch pipe through the levee was found. Limited access to levee crown, UCIP inspection was completed by accessing the opposite bank. (O. Magana - DWR UCIP)4/10/2017 Unable to locate. (DWR Sutter Yard- A Freitag)10/11/2016 Unable to locate.4/19/2016 Unable to locate.5/12/2015 Unable to locate.11/17/2014 Unable to locate.5/12/2014 Same as last inspection.11/4/2013 Same as last inspection.5/15/2013 Same as last inspection. Unable to locate.10/16/2012 Unable to locate. FIELD_STRUCT_DESC: 15-inch galvanized iron irrigation pipe through the levee, at an unknown depth. 15 horsepower (HP) pump and power pole located on the waterside (WS). [Additional Reference(s): DWR Levee Log, 1990. USACE Sacramento O&M Manual 135, May 1953, (HLM 0.27), Page 11, Location Section 10, As-Built Drawing No. 50-10-2816]. FS Date: 2/12/2019 12:15:00 PM

Overview of levee crown(high ground) photo taken from opposite bank.

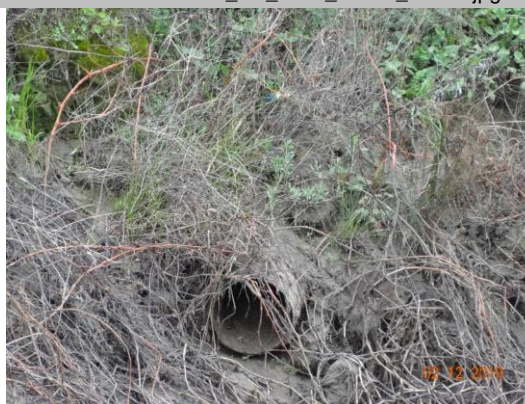
Photo 3 of 3 : UCIP\_SP\_2019\_53743\_78938.jpg

Comment Code						
Inspector Comment						
FS_ID:53743 DS_ID:19424 EP_NO: N/A Repair Type: Non-Urgent Crossing Status: Found UCIP Comments: 02/12/2019 Pump and power pole have been removed. 15-inch pipe through the levee was found. Limited access to levee crown, UCIP inspection was completed by accessing the opposite bank. (O. Magana - DWR UCIP)4/10/2017 Unable to locate. (DWR Sutter Yard- AFreitag)10/11/2016 Unable to locate.4/19/2016 Unable to locate.5/12/2015 Unable to locate.11/17/2014 Unable to locate.5/12/2014 Same as last inspection.11/4/2013 Same as last inspection.5/15/2013 Same as last inspection. Unable to locate.10/16/2012 Unable to locate. FIELD_STRUCT_DESC: 15-inch galvanized iron irrigation pipe through the levee, at an unknown depth. 15 horsepower (HP) pump and power pole located on the waterside (WS). [Additional Reference(s): DWR Levee Log, 1990. USACE Sacramento O&M Manual 135, May 1953, (HLM 0.27), Page 11, Location Section 10, As-Built Drawing No. 50-10-2816]. FS Date: 2/12/2019 12:15:00 PM

WS view: pipe found through bank.

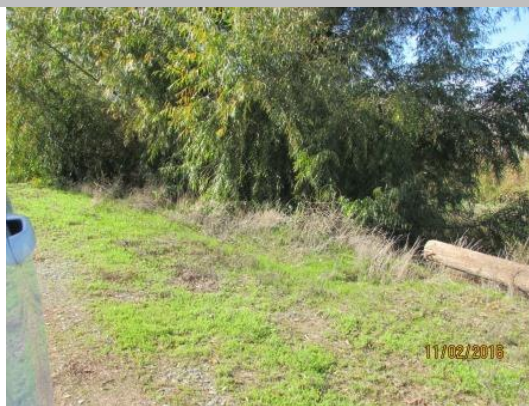
Photo 1 of 1 : SP\_2019\_ST0020\_214\_31\_20190327\_00013.jpg

View of the overgrown trees blocking visibility and access.

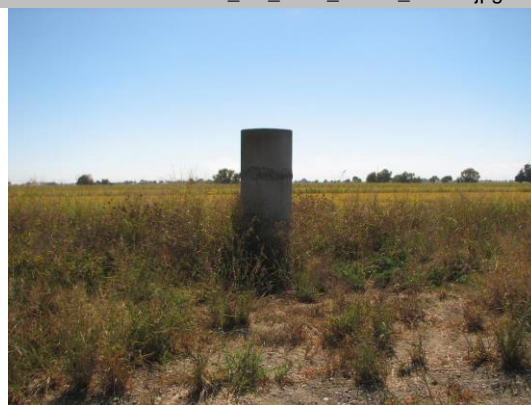
Photo 3 of 3 : UCIP\_SP\_2019\_53705\_11391.jpg

Concrete standpipe on LS shoulder.

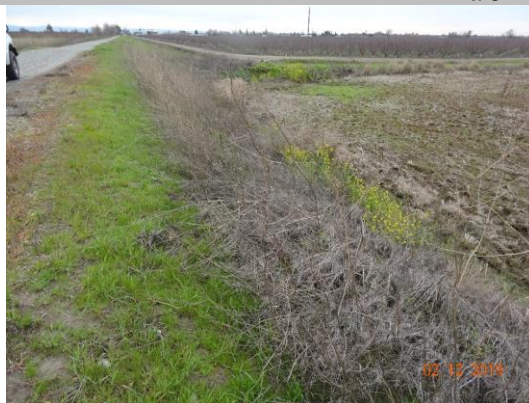
Photo 1 of 3 : UCIP\_SP\_2019\_53706\_78969.jpg

LS view: overview of LS no evidence of pipe found.

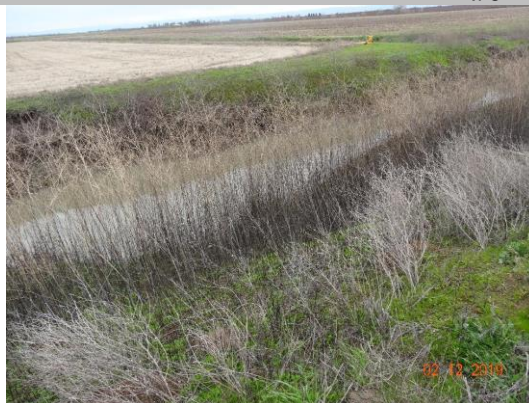
Photo 3 of 3 : UCIP\_SP\_2019\_53706\_78968.jpg

WS view: overview of WS no evidence of pipe found.

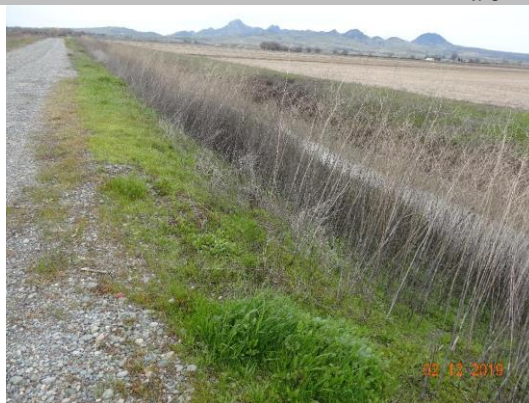
Photo 3 of 3 : UCIP\_SP\_2019\_53707\_78972.jpg

WS view: overview of WS no evidence of pipe found.

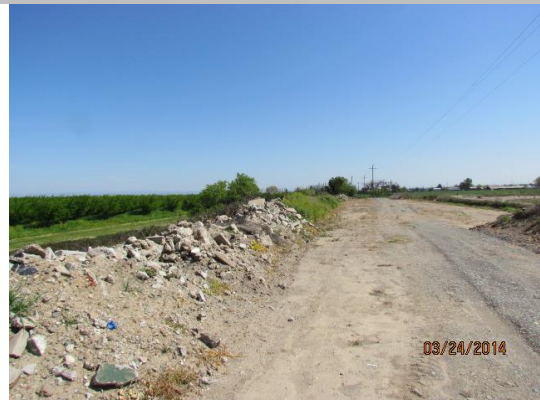
Photo 1 of 2 : SP\_2019\_ST0020\_214\_3\_20190327\_00001.jpg

View of the piles of broken concrete.

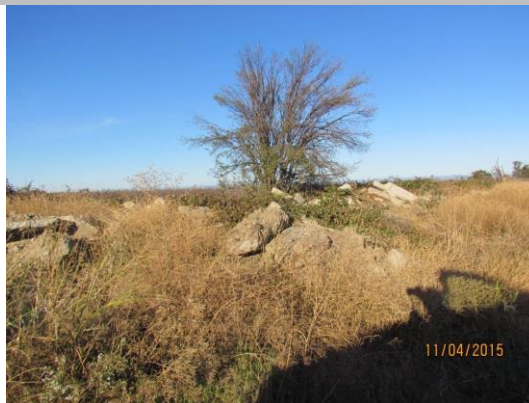
Photo 2 of 2 : SP\_2019\_ST0020\_214\_3\_20190327\_00002.jpg

View of the pile of broken concrete.

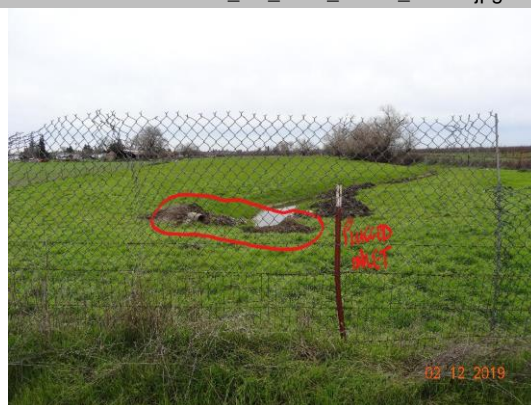
Photo 3 of 3 : UCIP\_SP\_2019\_53710\_78988.jpg

LS view: plugged inlet.

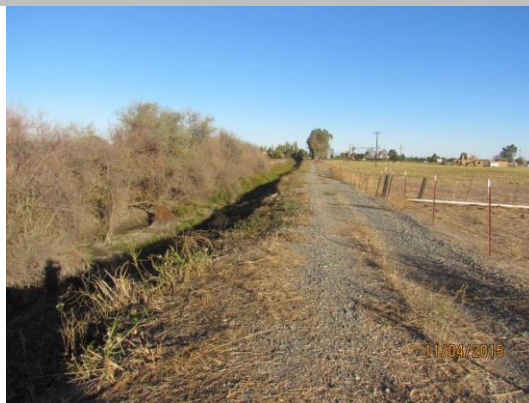
Photo 2 of 2 : SP\_2019\_ST0020\_214\_4\_20190327\_00004.jpg

View of the erosion along the waterside slope.

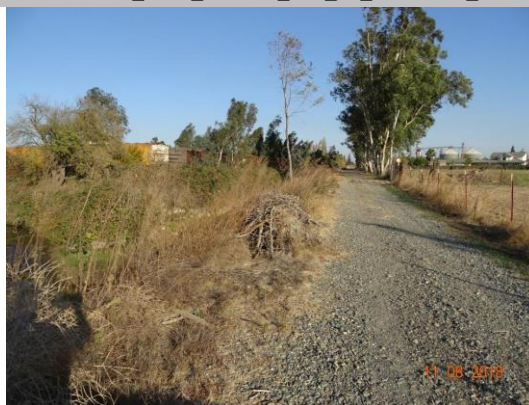
Photo 1 of 1 : SP\_2019\_ST0020\_214\_18\_20190327\_00008.jpg

View of the debris along the waterside berm.

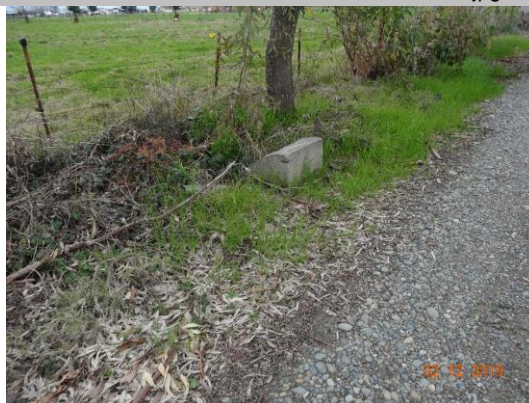
Photo 2 of 3 : UCIP\_SP\_2019\_53713\_79003.jpg

LS view: no evidence of 7-inch flexible HDPE pipe present on LS.

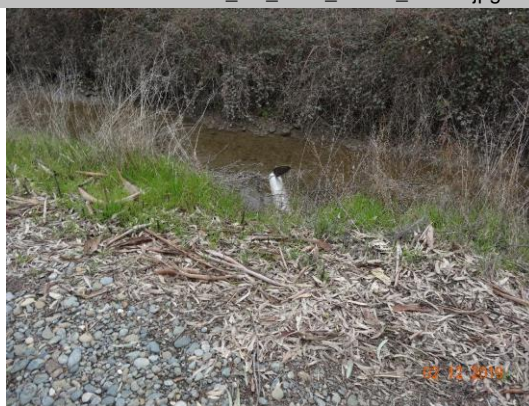
Photo 3 of 3 : UCIP\_SP\_2019\_53713\_79004.jpg

WS view: no evidence of 7-inch flexible HDPE pipe present on WS, only 5-inch steel pipe represent.

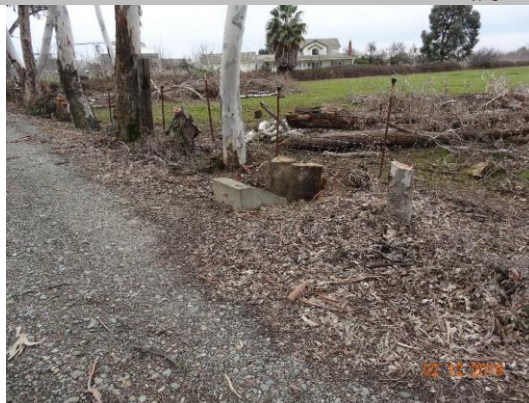
Photo 1 of 3 : UCIP\_SP\_2019\_53715\_79012.jpg

LS view: no evidence found on LS only concrete headwall associated with 5-inch drain pipe.

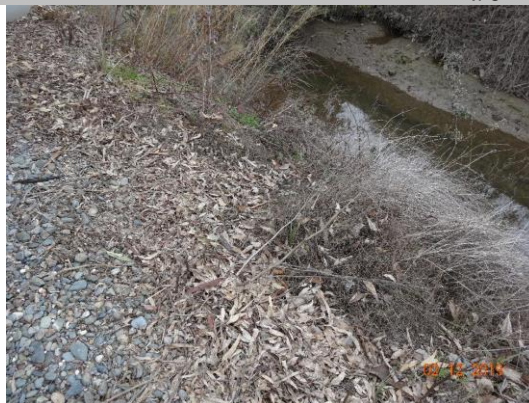
Photo 3 of 3 : UCIP\_SP\_2019\_53716\_79014.jpg

WS view: unable to locate pipe on WS.

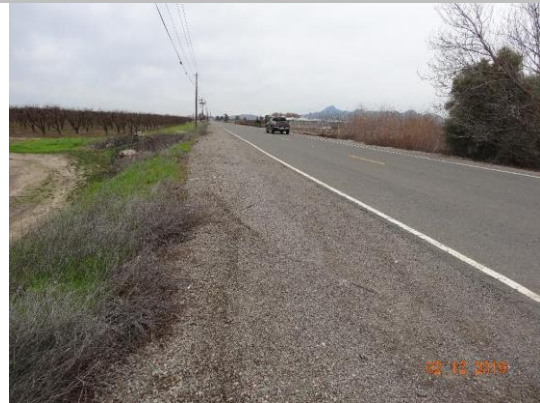
Photo 1 of 1 : UCIP\_SP\_2019\_53722\_79051.jpg

Overview of levee section where crossing should be, no evidence was found of crossing.
